MOORING CONDITION REPORT

**NORFOLK NAVAL
SHIPYARD**

CR-6119-OCN

September, 1999

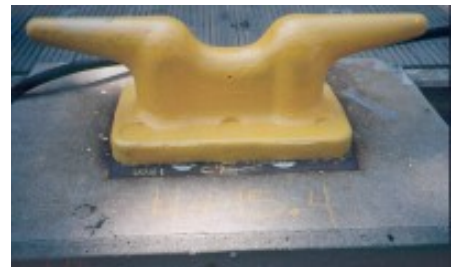
Photo 3.3-2 Berth 4, fitting WS1-C7, Sta. 4+15.4, 42-inch type 1 cleat in good condition, #1 rating

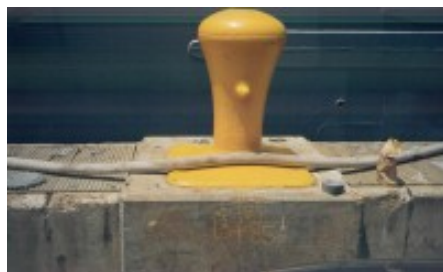
Photo 3.3-5 Berth 5, fitting WS1-B5, Sta. 13+55.5, 50 ton bollard in good condition, #2 rating

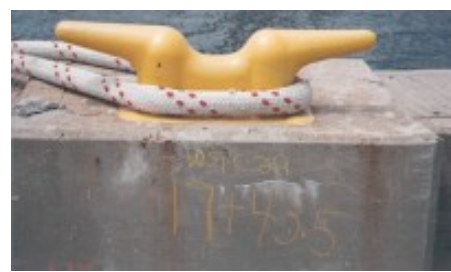
Photo 3.3-6 Berth 6, fitting WS1-C29, Sta. 17+14 42-inch type 1 cleat in good condition, concrete base exhibits cracking resulting in a #3 rating

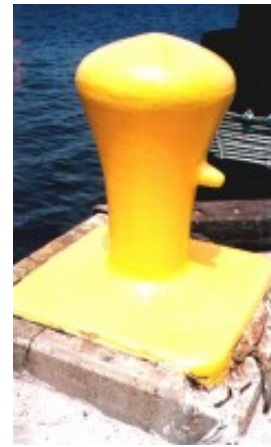
Photo 3.3-8 Berth 6, fitting WS1-B8 Sta. 17+78.5, 50 ton, bollard with cracking of the concrete base resulting in a #3 rating

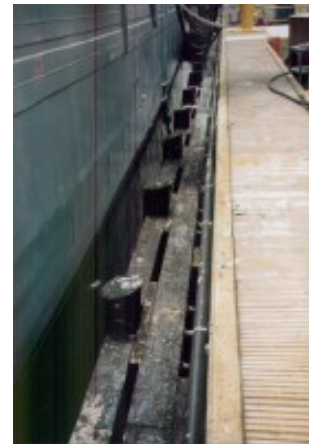
Photo 3.3-10 Berth 3, fender system in good operational condition overview looking west

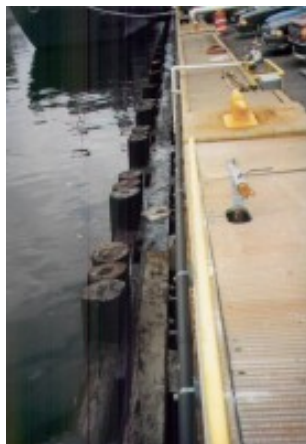
Photo 3.3-11 Berth 4, fender system in good operational condition overview looking west

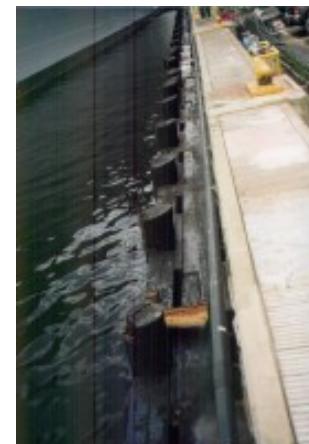
Photo 3.3-12 Berth 5, fender system in good operational condition overview looking east

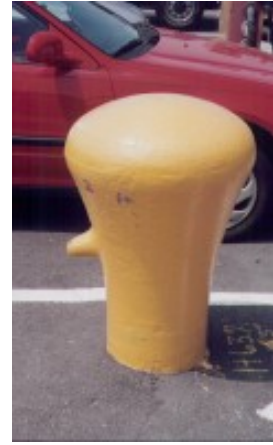
Photo 3.4-2 Berth 7, fitting B7-B2, Sta. 1+63.7, 50 ton bollard, base paved over, #1 rating

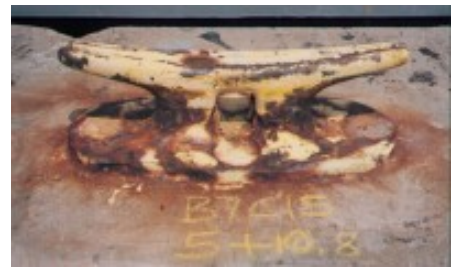
Photo 3.4-4 Berth 8, fitting B7-C15, Sta. 5+10.8, 26-inch cleat exhibits heavy scaling, #2 rating

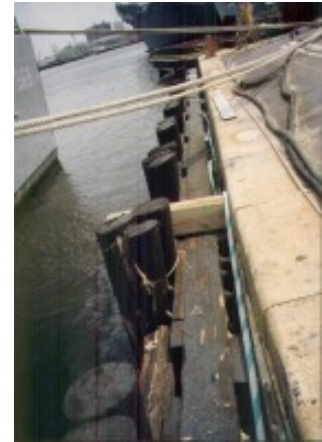
Photo 3.4-6 Berths 7 & 8, fender system in good operational condition overview looking south

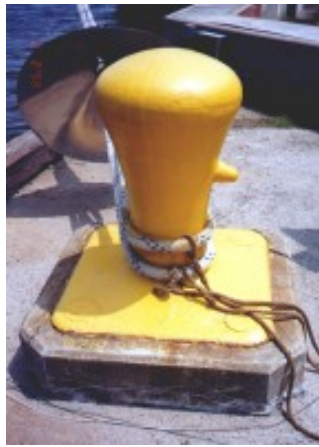
Photo 3.4-7 Berth 7, fitting B7-B1, Sta. 0+11.6, 50-ton bollard with cracking of the concrete base, #3 rating

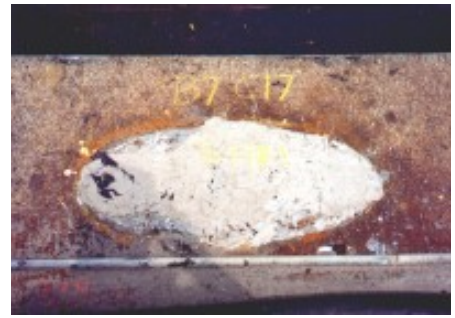
Photo 3.4-8 Berth 7, fitting B7-C17, Sta. 6+18.1, 26" cleat bolts are sheared off and cleat is missing, #4 rating

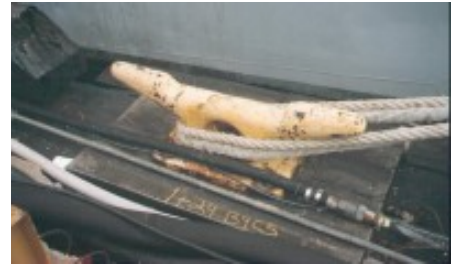
Photo 3.5-2 Berth 9, fitting B9-C5, Sta. 1+24, 42" type 3 cleat in good condition, #2 rating

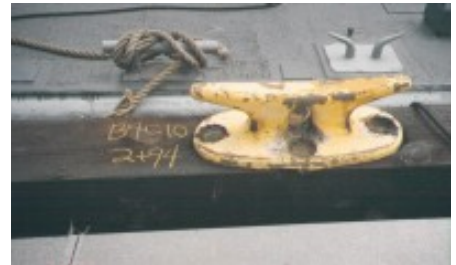
Photo 3.5-4 Berth 9, fitting B9-C10, Sta. 2+94, 26" cleat in good condition, #1 rating

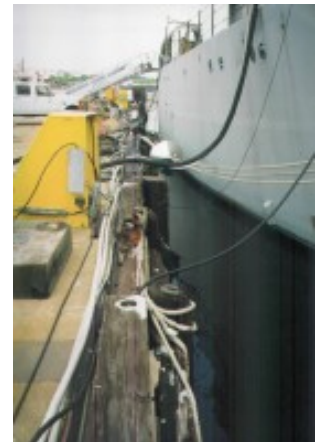
Photo 3.5-8 Berth 9, fender system with moderate deterioration looking east

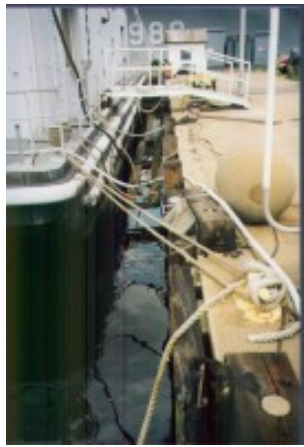
Photo 3.5-9 Berth 10, fender system with moderate deterioration looking east

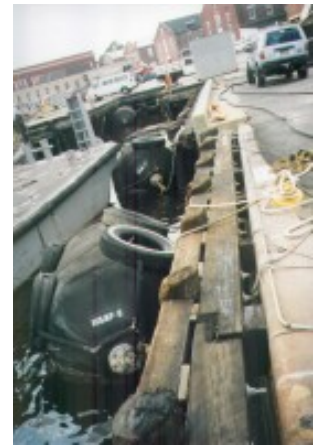
Photo 3.5-10 Berth 10, Ferry slip, fender system with minor deterioration looking west

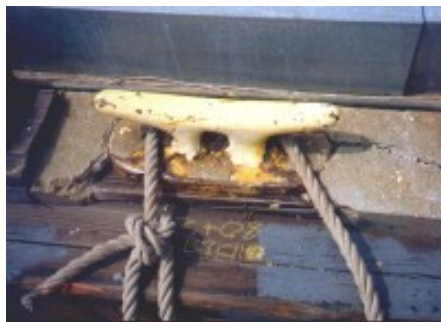
Photo 3.5-11 Berth 9, fitting B9-C1, Sta. 18, 42" cleat (Type 1) timber base exhibits dry rot, #3 rating

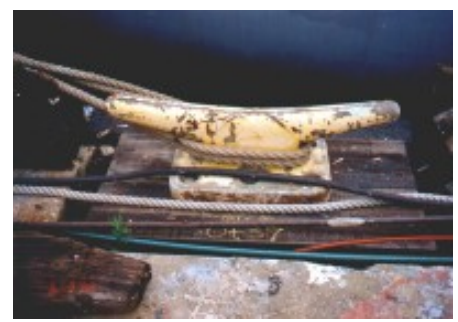
Photo 3.5-12 Berth 9, fitting B9-C2, Sta. 37, 42" cleat (Type 1) timber base exhibits dry rot, #4 rating

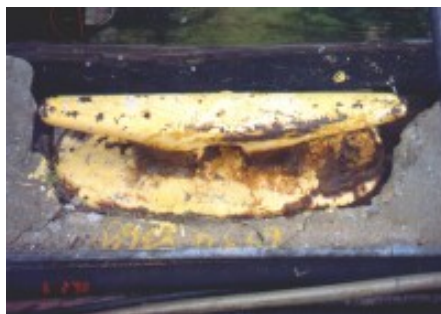
Photo 3.5-13 Berth 9, fitting B9-C3, Sta. 69, 26" cleat timber base exhibits dry rot, #3 rating

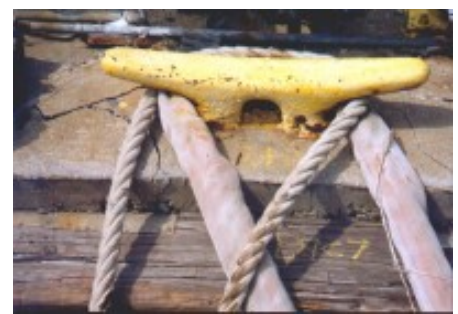
Photo 3.5-14 Berth 9, fitting B9-C7, Sta. 2+27, 26" cleat, timber base exhibits dry rot, #3 rating

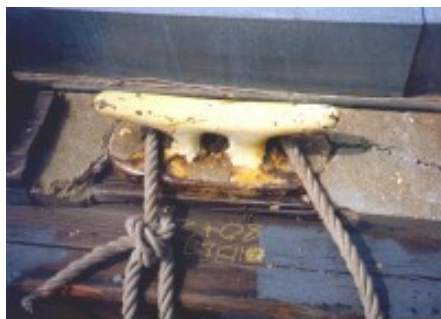
Photo 3.5-15 Berth 9, fitting B9-C11, Sta. 3+08, 26" cleat, timber base exhibits dry rot, #3 rating

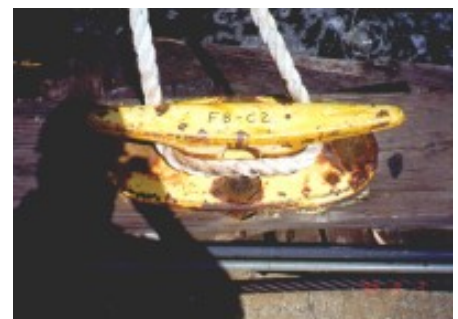
Photo 3.5-16 Ferry Slip, fitting FS-C2, Sta. 1+04, 26" cleat timber base exhibits dry rot, #4 rating

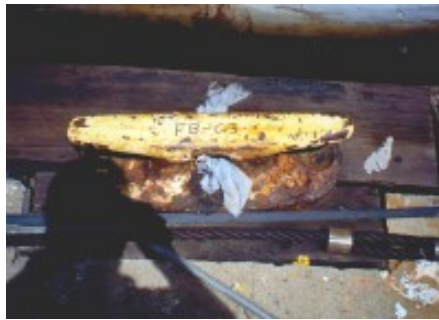
Photo 3.5-17 Ferry Slip, fitting FS-C3, Sta. 1+23, 26" cleat timber base exhibits dry rot, #3 rating

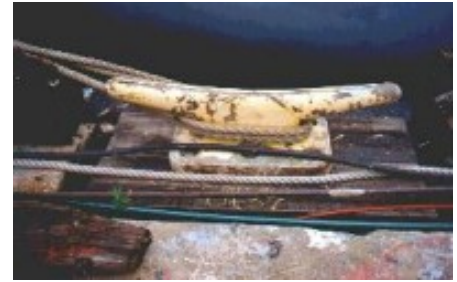
Photo 3.5-18 Ferry Slip, fitting FS-C4, Sta. 1+61, 26" cleat timber base exhibits dry rot, #3 rating

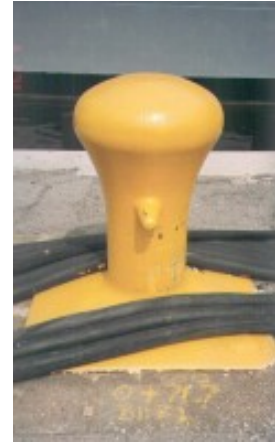
Photo 3.6-2 Berth 11, fitting B11-B2, Sta. 0+71.7, bollard in good condition, #1 rating

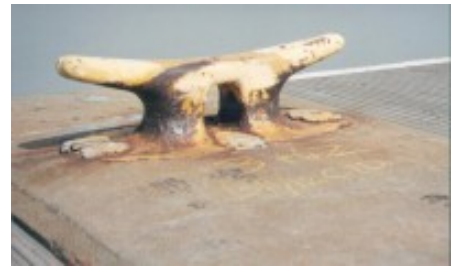
Photo 3.6-4 Berth 12, fitting B11-C10, Sta. 3+62, 26" cleat exhibiting corrosion, #2 rating

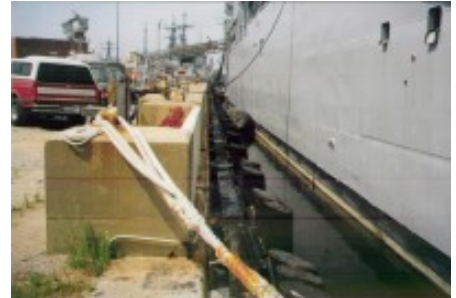
Photo 3.6-6 Berth 11 & 12, fender system in good operational condition looking north

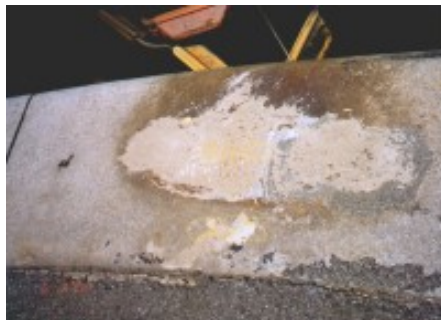
Photo 3.6-7 Berth 11, fitting B11-C2, Sta. 0+55, 26" cleat, fitting is missing, #4 rating

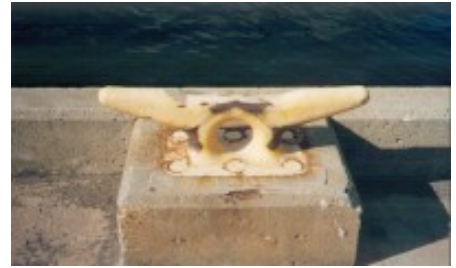
Photo 3.7-2 Berth 13, fitting B13-C1, Sta. 0+59 42" type 3 cleat in good condition, #2 rating

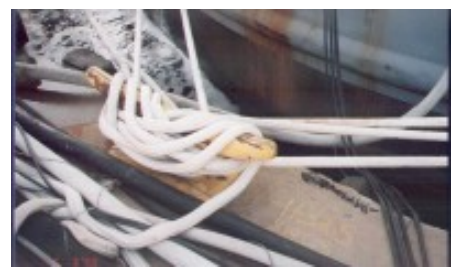
Photo 3.7-4 Berth 14, fitting B14-C3, Sta. 1+32, 42" type 2 cleat in good condition, timber blocking below deck exhibits rot, #3 rating

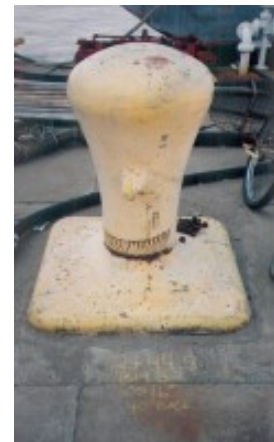
Photo 3.7-6 Berth 15, fitting B14-B2, Sta. 24+45, bollard in good condition, #2 rating

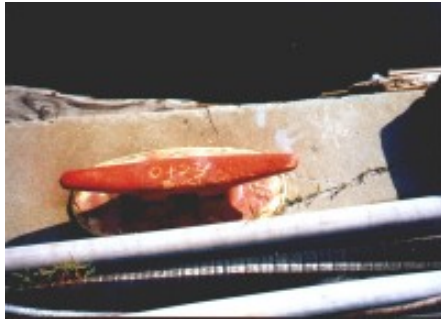
Photo 3.7-7 Berth 16, fitting B16-C1, Sta. 0+23 26" cleat, base exhibits cracking resulting in a #4 rating. Note that cleat is painted red as a warning to facility users

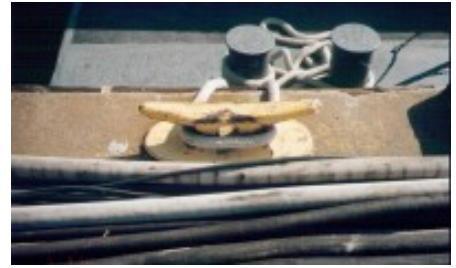
Photo 3.7-8 Berth 16, fitting B16-C2, Sta. 0+42.4 26" cleat in good condition, #1 rating

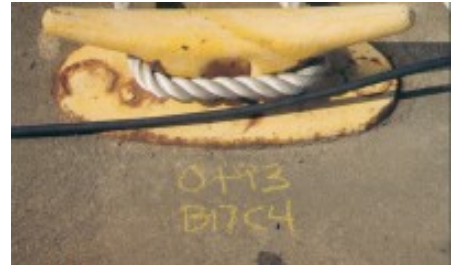
Photo 3.7-10 Berth 17, fitting B17-C4, Sta. 0+93 26" cleat in good condition, #2 rating

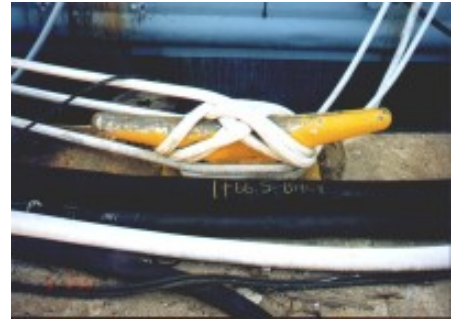
Photo 3.7-16 Berth 14, fitting B14-C4, Sta. 1+66.5, Type 2 42" cleat, timber blocking below deck exhibits dry rot, #3 rating

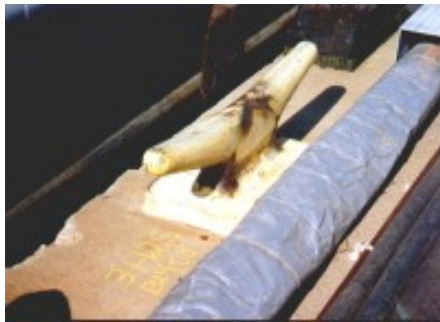
Photo 3.7-17 Berth 15, fitting B14-C8, Sta. 3+12.5, 42" Type 2 cleat, timber blocking below deck exhibits dry rot, #3 rating

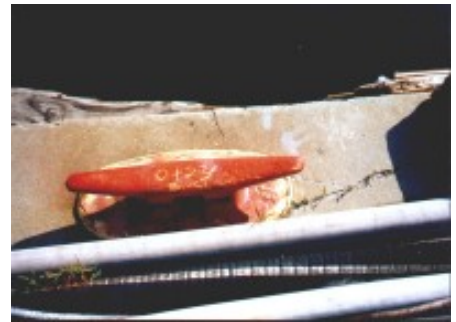
Photo 3.7-18 Berth 16, fitting B16-C1, Sta. 0+23, 26" cleat, concrete base exhibits cracking, #4 rating

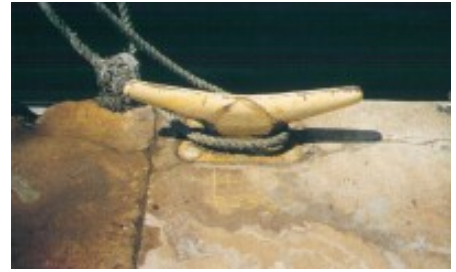
Photo 3.9-4 Berth 23, fitting B23-C3, Sta. 1+02 42" type 2 cleat, #2 rating

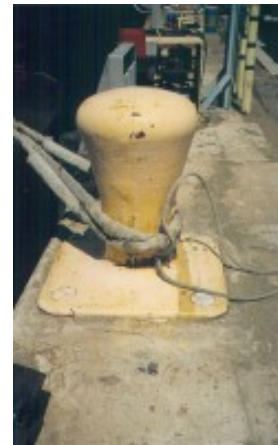
Photo 3.9-6 Berth 23, fitting B23-B3, Sta. 2+29, bollard in good condition, #2 rating

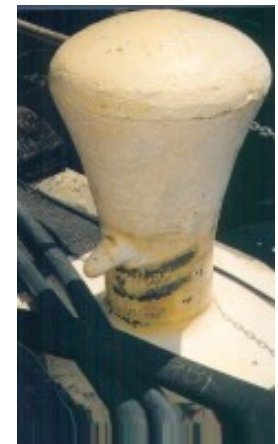
Photo 3.9-8 Berth 24, fitting B23-B10, Sta. 9+33, bollard in good condition, #2 rating

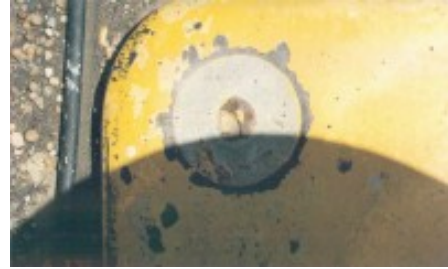
Photo 3.10-4 Berth 25, fitting B25-B2, Sta. 1+97 bollard, close-up of bolt end

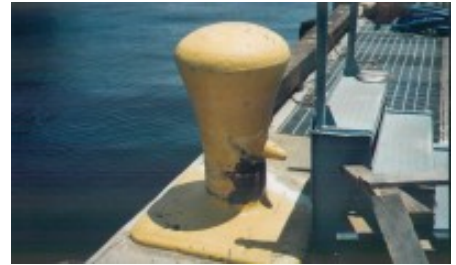
Photo 3.11-4 Berth 26, fitting B26-B3, Sta. 2+64, bollard
in good condition, #2 rating

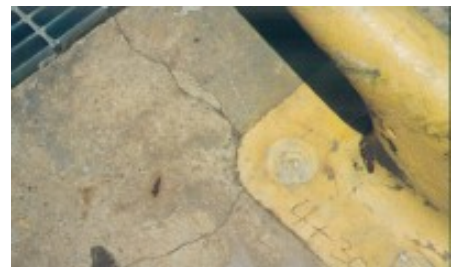
Photo 3.11-6 Berth 26, fitting B26-C9, Sta. 4+30, 42"
type 2 cleat close-up of cracked concrete at base

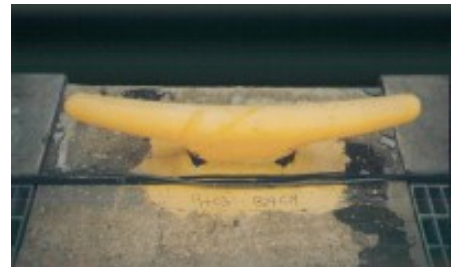
Photo 3.11-17 Berth 30, fitting B29-C15, Sta. 7+13, 42" type 1 cleat in good condition, #2 rating

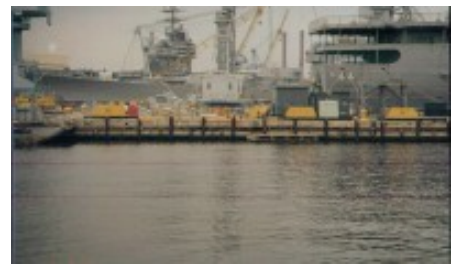
Photo 3.11-19 Berth 26, fender system with minor deterioration looking south

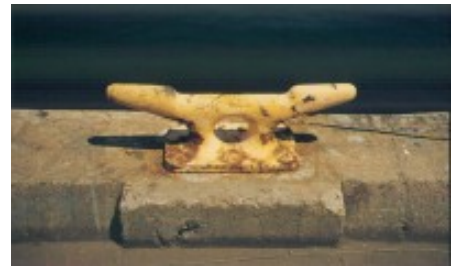
Photo 3.12-4 Berth 31, fitting 31-C6, Sta. 2+60, 42" type 3 cleat in good condition, #2 rating

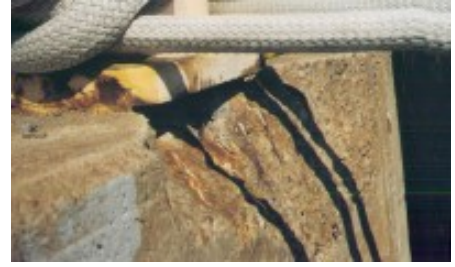
Photo 3.13-20 Berth 36, fitting B35-C19, Sta. 4+52, 42" type 3 cleat, close-up view of damaged concrete edge

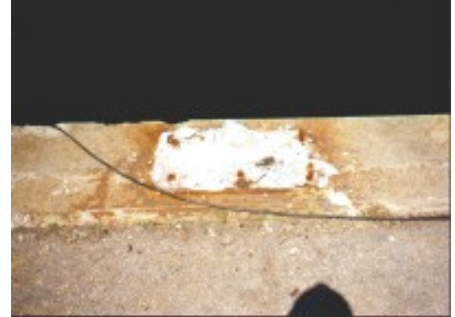
Photo 3.13-22 Berth 32, fitting B32-C1, Sta. 0+30, 42" type 1 cleat, cleat is missing, rating #4

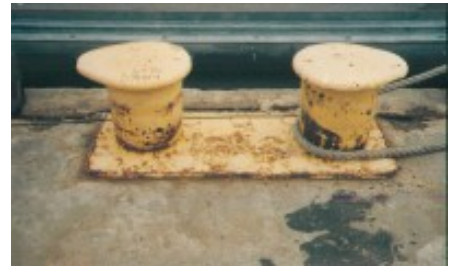
Photo 3.15-8, Berth 38, fitting B38-BT4, Sta. 6+70, low double bitt in good condition, #2 rating.

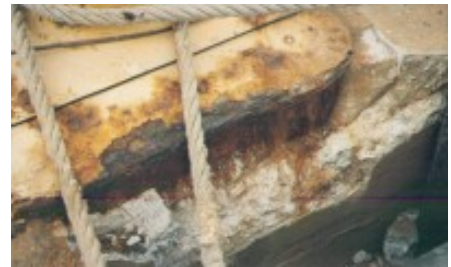
Photo 3.15-10, Berth 38, fitting B38-B4, Sta. 7+66 , close up view of damaged concrete edge.

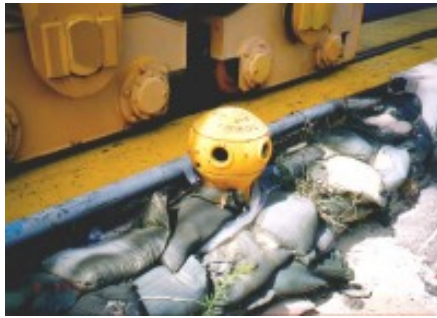
Photo 3.17-11 Dry Dock 1, fitting DDIP-CP3, windlass crack noted on fitting base, #3 rating.

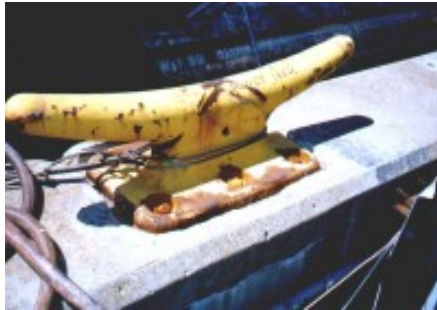
Photo 3.18-14, Dry Dock 2, fitting DD2S-C14, 42" type 1 cleat in good condition, # 2 rating.

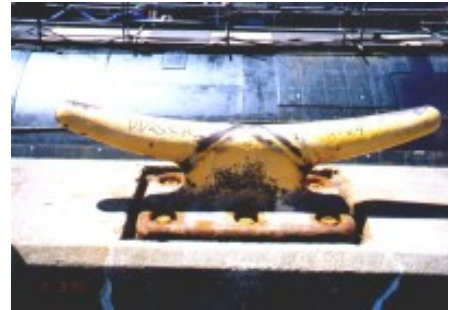
Photo 3.18-15, Dry Dock 2, fitting DD2S-C7, Sta. 1+65, 42" Type 2 cleat, ungrouted base and bolt pockets not filled, #3 rating.

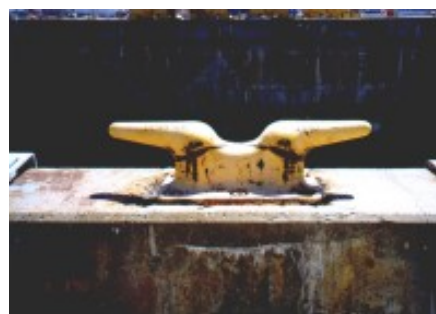
Photo 3.19-8, Dry Dock 3, fitting DD3S-C8, Sta. 2+90, 42" Type 1 cleat, ungrouted base and bolt pockets not filled, #3 rating.

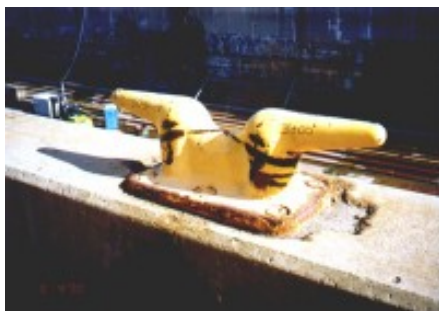
Photo 3.19-9, Dry Dock 3, fitting DD3P-C8, Sta. 3+00, 42" Type 1 cleat, ungrouted base and bolt pockets not filled, #3 rating.

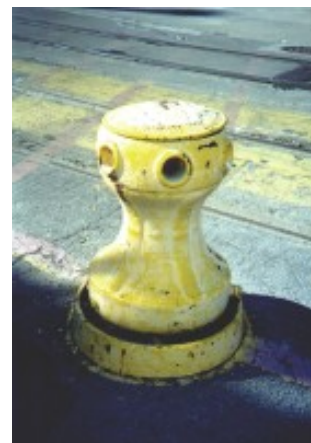
Photo 3.20-12, Dry Dock 4, fitting DD4P-CP8 Sta. 7+97, windlass top plate is cracked and is missing several ratchet dogs, #3 rating.

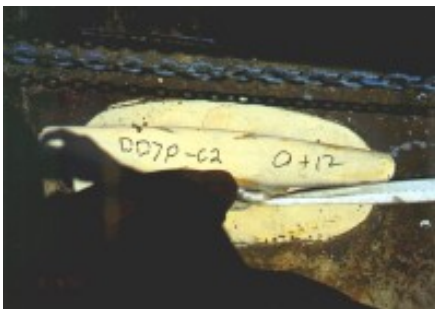
Photo 3.21-17, Dry Dock 7, fitting DD7P-C2, Sta. 0+12, 26" cleat, cracking noted at concrete base, #3 rating.
